**AV-803-1-K-C PROPELLER SERIES
INSPECTION OF COUNTERWEIGHT BOLTS AND COUNTERWEIGHT
REPLACEMENT**

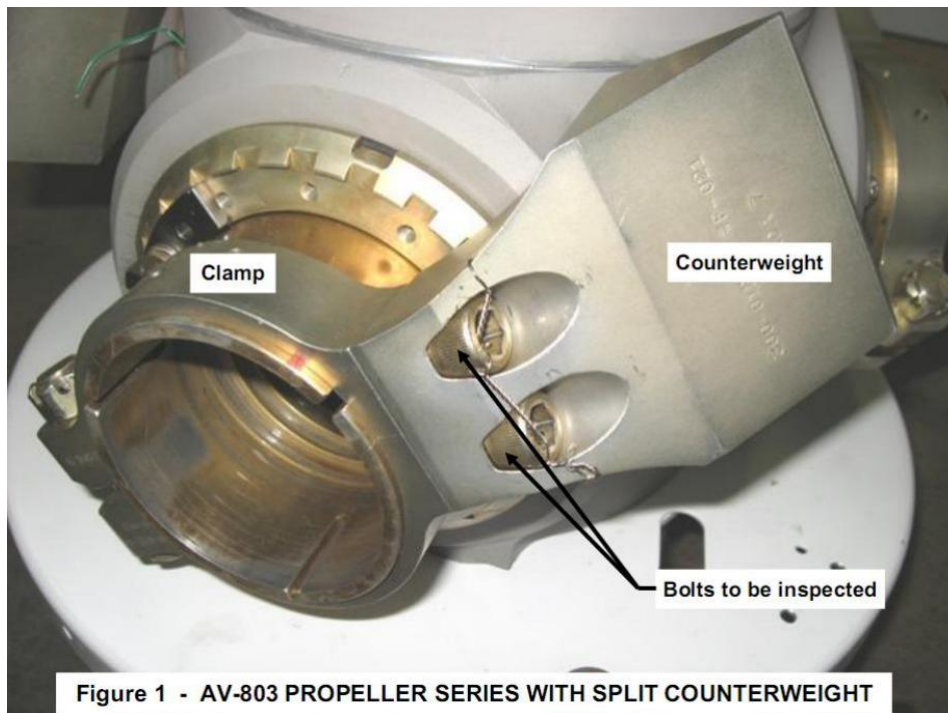
Failure on a counterweight bolt.

Split counterweight is displayed in figure 1. One-piece counterweight is displayed in figure 2.

- A. **If any movement of the bolt is not present, the propeller can flight next 10 hours. Repeat this 10 hours inspection cycle until the split counterweight will be replaced by one-piece counterweight. The split counterweight must be replaced by one-piece counterweight.**
- B. **If any bolt movement is detected, remove the propeller from the service.**
- C. After the inspection is finished, safety the bolts with 0,8mm dia safety wire.
- D. Make a record into the Propeller Logbook.

E. Avia Propeller will arrange replacement of those two-pieces counterweights by one-piece counterweight.
